Mountain Valley Stone Northeastern Mine Reclamation

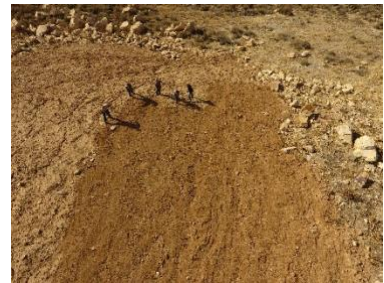
Before reclamation of the area began, Mountain Valley Stone had done some preparation work. "Top Soil from stockpiles [were] moved during reclamation and spread on the surface of the quarry. The mixture [was] approximately 4-6 inches thick. Soil materials [were] spread with a rubber tired front end loader after ripping roads and compacted areas and restoration contouring has been completed". In regards to the seed bed preparation, Mountain Valley Stone ripped certain "compacted disturbed areas other than roads . . . to a depth of 6-12 inches with the ripper spaced at the maximum of two feet. The surface was left in a slightly rough condition immediately prior to addition of topsoil and seeding. The compacted surfaces of the road ways were ripped to a depth of 18-24 inches and also left in a graded but slightly rough condition."

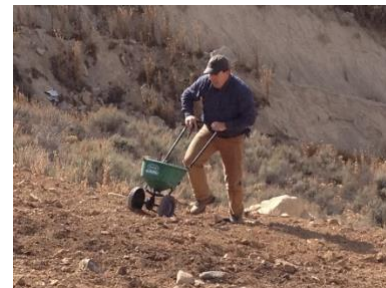
property. Using recommendations from DOGM biologists appropriate amount of each seed for the 2.1 acre reclamation area was obtained from Granite Seed company in Lehi Ut. The topsoil was disturbed to accept the seed from the broadcast spreader to distribute the seed mix. On the steeper and lower portion of the area small terraces were raked in to better hold water and give some resistance to erosion. In the upper northwest corner of the reclamation area, a layer of planting mulch was spread over the seed. This area was 560 square ft in size. This will serve as a test plot to see if the increase in mulch will aid in seed germination. After broadcasting the seed CAPS students lightly raked the soil to cover the seed and protect it against wind, birds and other wildlife. To help promote germination and plant growth 20 lbs of urea based nitrogen fertilizer or (46-0-0) was evenly applied to the reclamation area.

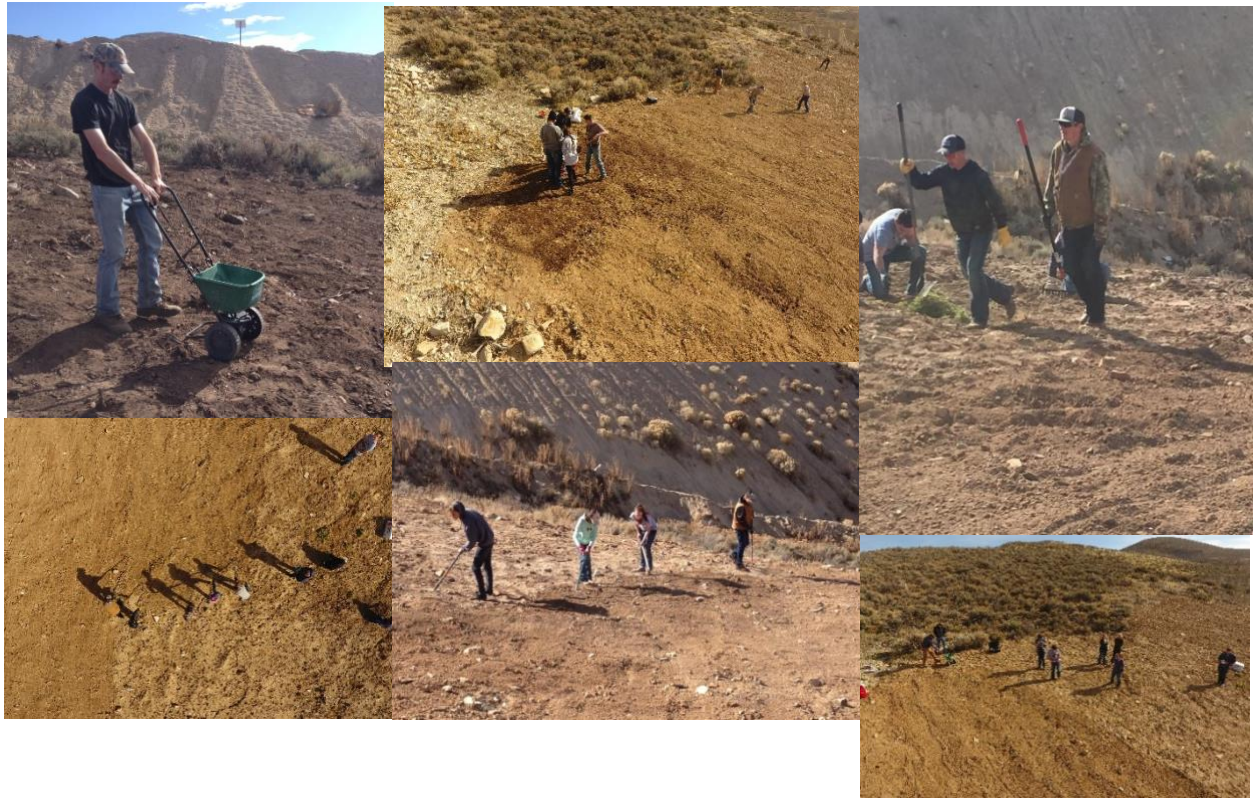
During the germination we will be monitoring through aerial imagery and transect lines. This upcoming spring, using aerial photography, the stone quarry will be closely monitored. The percent of cover will be determined after monitoring. Growth progress and overall plant vigor will be monitored using NDVI Filters applied to aerial imagery. Transect Lines will provide a way to observe changes taking place in the reclamation area over time.

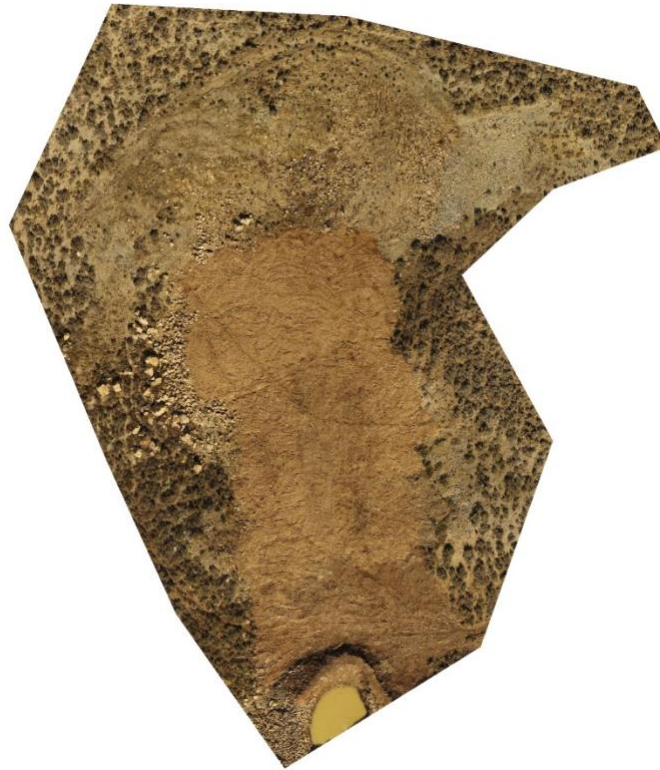
Aerial photography: Through the use of a DJI Phantom 4 drone and the software DroneDeploy, aerial photographs will be collected at regular intervals in order to monitor long term growth.
